REPORT
OF THE
OPERATIONAL SAFETY REVIEW TEAM
(OSART)
TO THE
TRICASTIN
NUCLEAR POWER PLANT
FRANCE

28 NOVEMBER – 15 DECEMBER 2022

DIVISION OF NUCLEAR INSTALLATION SAFETY
OPERATIONAL SAFETY REVIEW MISSION
IAEA-NSNI/OSART/215

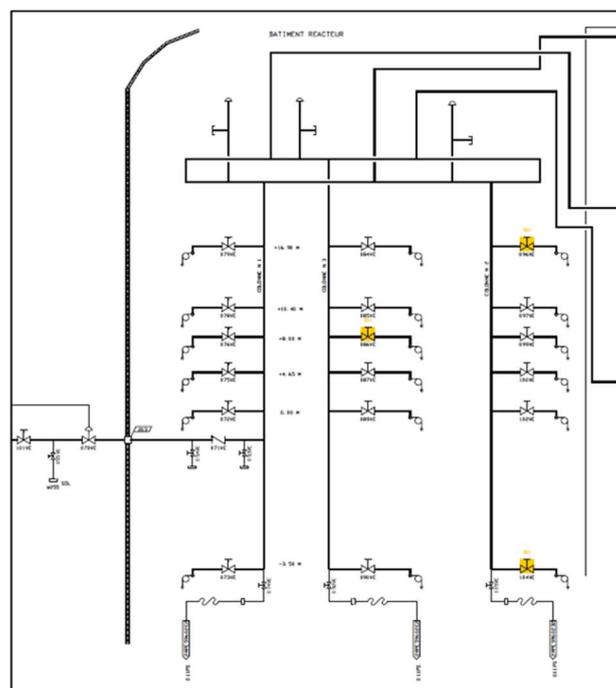
Visualization of works on flow diagrams

- An automatic detection of slow adverse trends.
- An automatic visualization of preventive and corrective works directly on flow diagrams, which allow for easy detection of higher threats on specific systems or trains and for example, can trigger a re-prioritization of maintenance activities.

- Synoptic screens present in real time, a ‘bird’s eye’ vision of systems or functions. Synoptics facilitate the overall assessment of safety systems reliability during the morning engineering meeting.

The interface of this tool is easy to use.

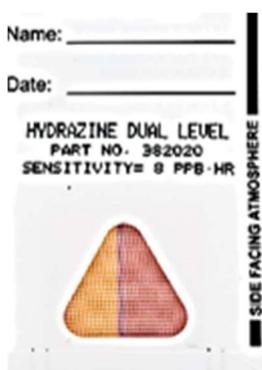
Personal hydrazine exposure meter

The plant uses a passive hydrazine dosimeter which accumulates the quantity of hydrazine absorbed and indicates in real time the PEL. The current means of measuring hydrazine vapors, both mobile and fixed, only measures the real-time concentration. To take into account the cumulative exposure to the vapors in accordance with the European directive, a new detector is used. This complies with the requirements of the directive on the Limit Value of Professional Exposure (VLEP).

- Safety gain: reduction of the personnel's exposure to hydrazine
- Operational gain: the personnel is more serene during interventions because they can visually control their exposure in real time.
- Potential financial gain: early detection of exposure will avoid medical expenses in case of occupational disease.

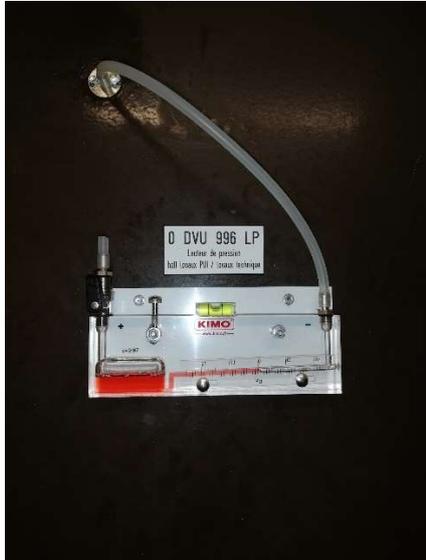
9.2.(a) Good practice: Differential pressure gauge indicating the pressure difference between inner and outer spaces mounted on the entrance door

Each room or building during radiological event shall be equipped with equipment or tools for differential pressure measurement.

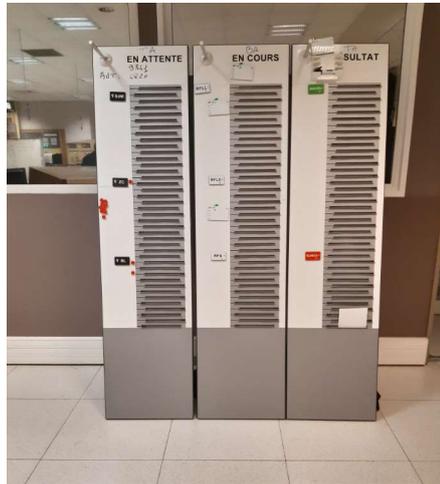
The ‘TABATA’ board comprises three columns in which the control room operators, the supervisor or field operators retrieve instructions for work to be carried out on plant.

Emergency operating procedures (EOP) and severe accident management guidelines (SAMG) refer to instructions for use on plant: RFL (line-ups), RFLE (electrical work instructions) and RFAG (instructions to be applied in severe accident conditions).

Before ‘TABATA’, there was no specific system for shelving ‘pending’ instructions and having a concise overview of results and of the ongoing situation. Instructions are placed in three ‘TABATA’ columns:
